Northern Arizona University

APS Transformer Final Report

Cholla Unit 2 Generation Step Up XFMR

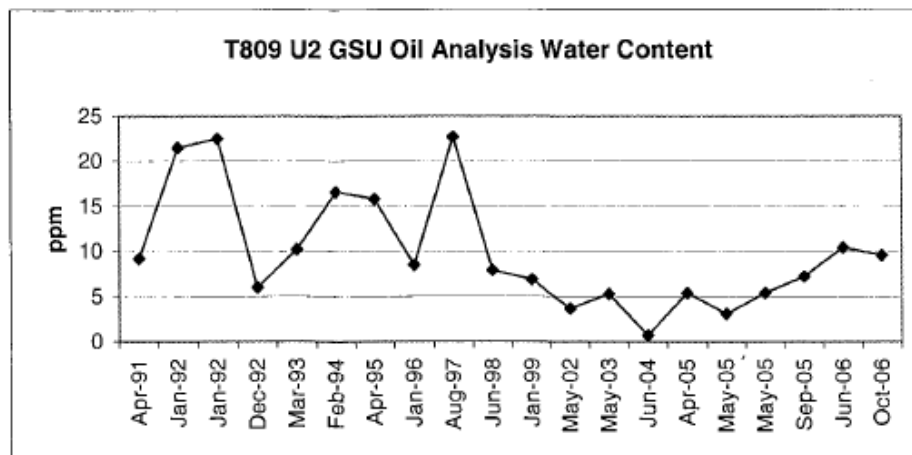
Figure 2

Relatively early on in the transformer's life, there were spikes in the water content within the transformer. This could have happened due to poor insulation outside of the transformer which let moisture inside the transformer as well as other factors within the transformer. In figure 2, shows steep spikes as well as sharp drops in water content inside the transformer. These step drops could be from result of APS fixing the transformer from year to year due to the sudden increases in water content. As the timeline continues to October 2006, the water content levels in the transformer

start to stabilize at 10 ppm but those early fluctuations could have caused damage to other parts of the transformer.

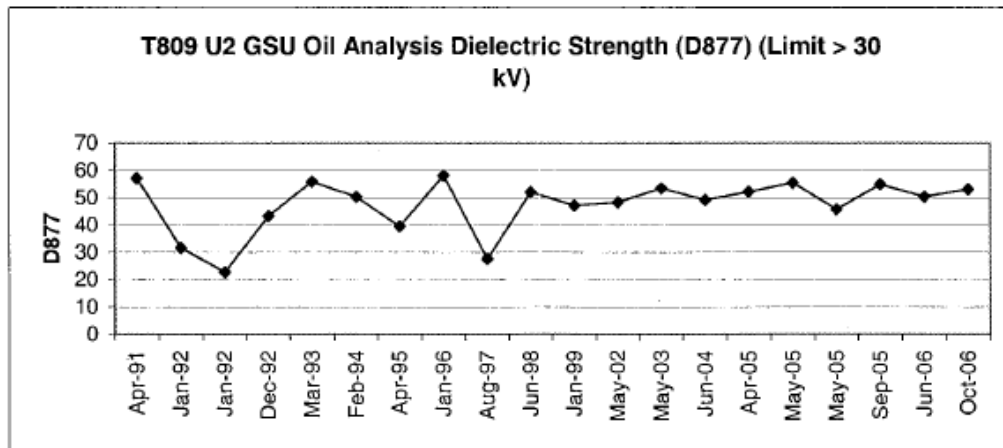
Potential residual effects from the steep variations in the water content could have caused drops in the strength of the dielectric properties of the insulating oil. Figure 3 shows results from a dielectric breakdown test which measured the voltage at which the dielectric strength of the oil breaks down [9]. The graph in figure 3 shows a sudden drop of the dielectric strength of the material to its lowest value during January 1992, the same date that the water content levels were at their highest. As the water content stabilizes, the dielectric strength of the oil also stabilizes. These two graphs show an inverse relation between the water content and the dielectric strength of the liquid insulation inside the transformer. As the water content level rises, the dielectric material falls at almost the same rate as the water content level.

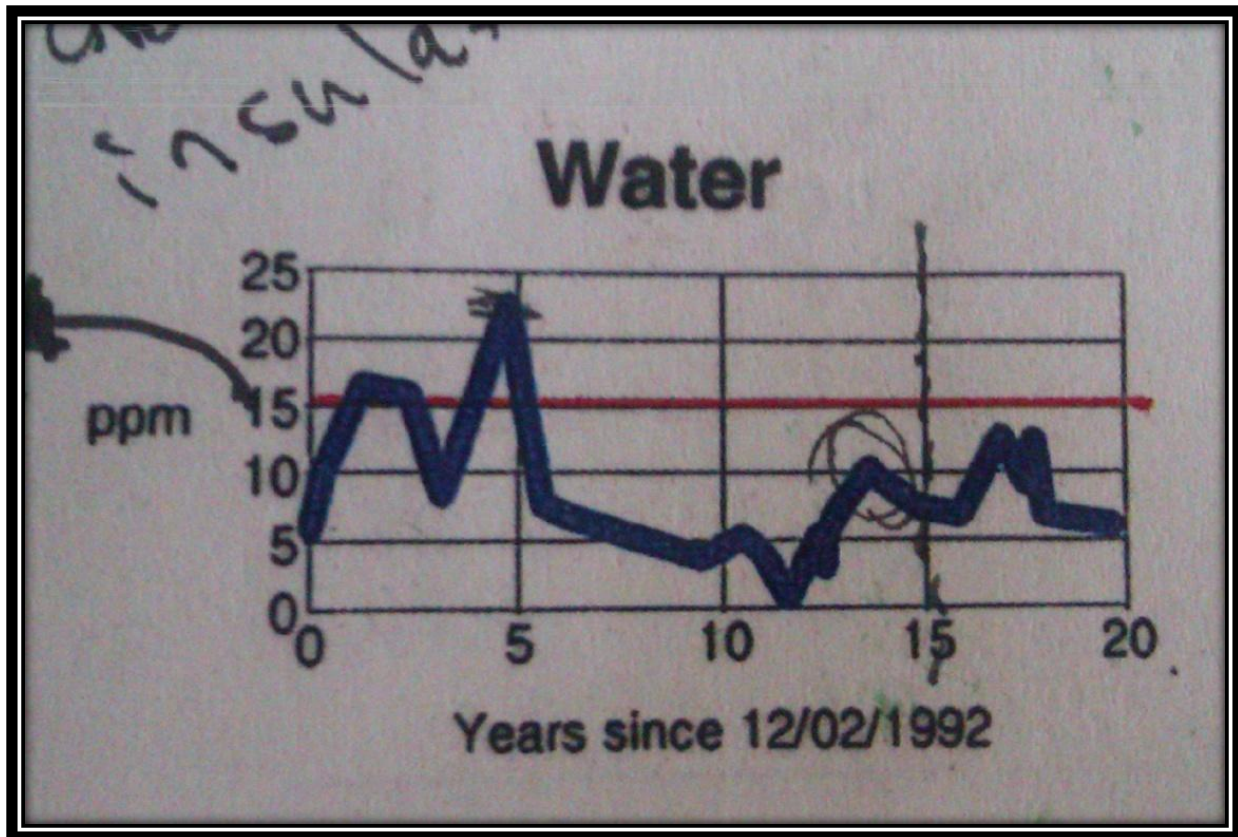
Figure 5
Dissolved Gas Analysis Data Received from APS

Relatively early on in the transformer's life, there were spikes in the water content within the transformer. In Figure 5, shows steep spikes as well as sharp drops in water content inside the transformer. These step drops could be from result of APS fixing the transformer from year to year due to the sudden increases in water content. As the timeline continues to October 2006, the water content levels in the transformer start to stabilize at 10 ppm but those early fluctuations could have caused damage to other parts of the transformer. The water content in the oil goes over 15 ppm in the water content test three times and has past 20 ppm once sense 1991(close to half the transformer's total life). The Bureau of Reclamation has recommended that transformers over 230kV should never exceed 12 ppm so this water level in the oil of the transformer could be a sign of problems in the transformer. These levels of moisture in a transformer could have happened due to small oil leaks which will allow moisture in the transformer as well as the degradation of the solid insulation.

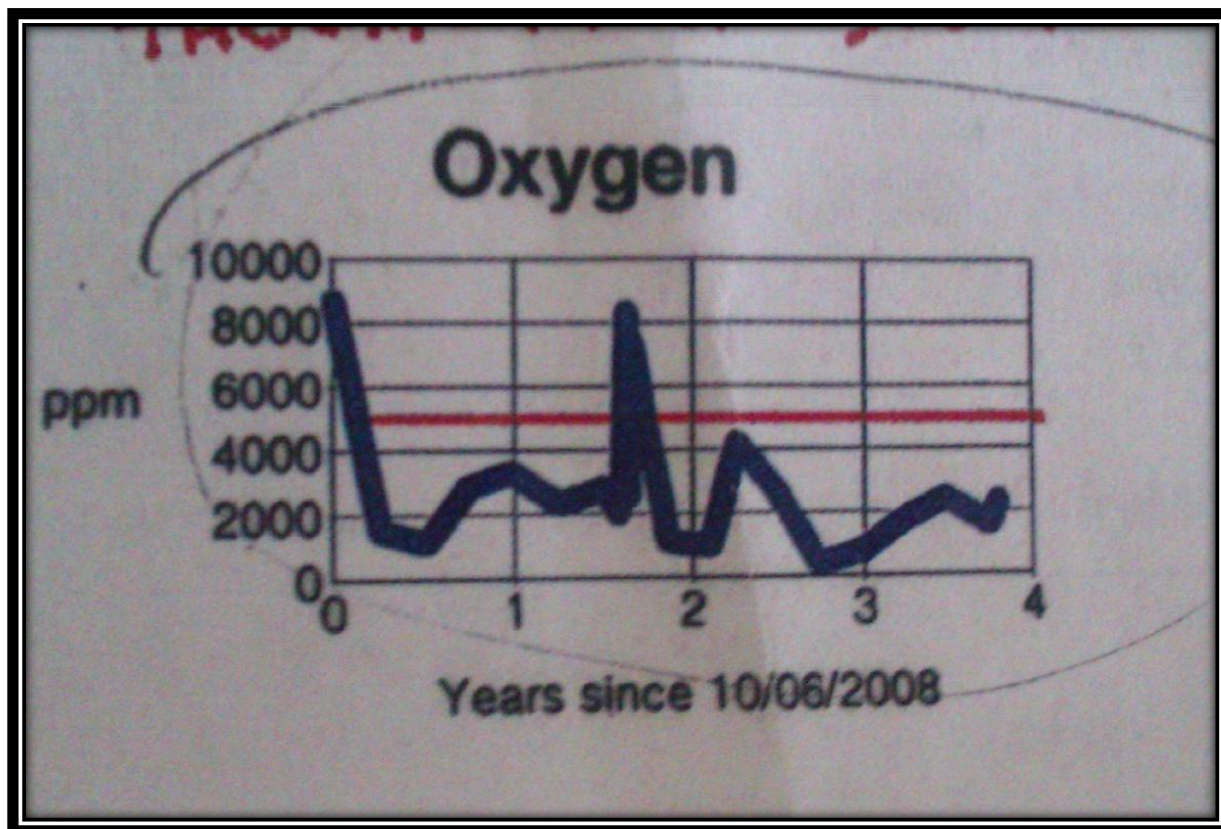
Figure 7
Dissolved Gas Analysis Data Received from APS

It is critical for life extension to keep transformers as dry and as free of oxygen as possible. Cellulose degrades much faster than oil because it contains oxygen within its molecular structure. The degradation process generates water, carbon dioxide and furfurals, and is accelerated by external sources of oxygen, high temperature and high levels of oil acidity. The dissolved gas analysis data we received from APS in Figure 7 shows that there was a spike of oxygen close to two years ago. This spike of oxygen does not help the life of the transformer but stands as an incident that would reduce the life of the transformer. The rise in oxygen could signal more water that was added to the paper insulation and signal further reduction of the insulating properties of the paper.

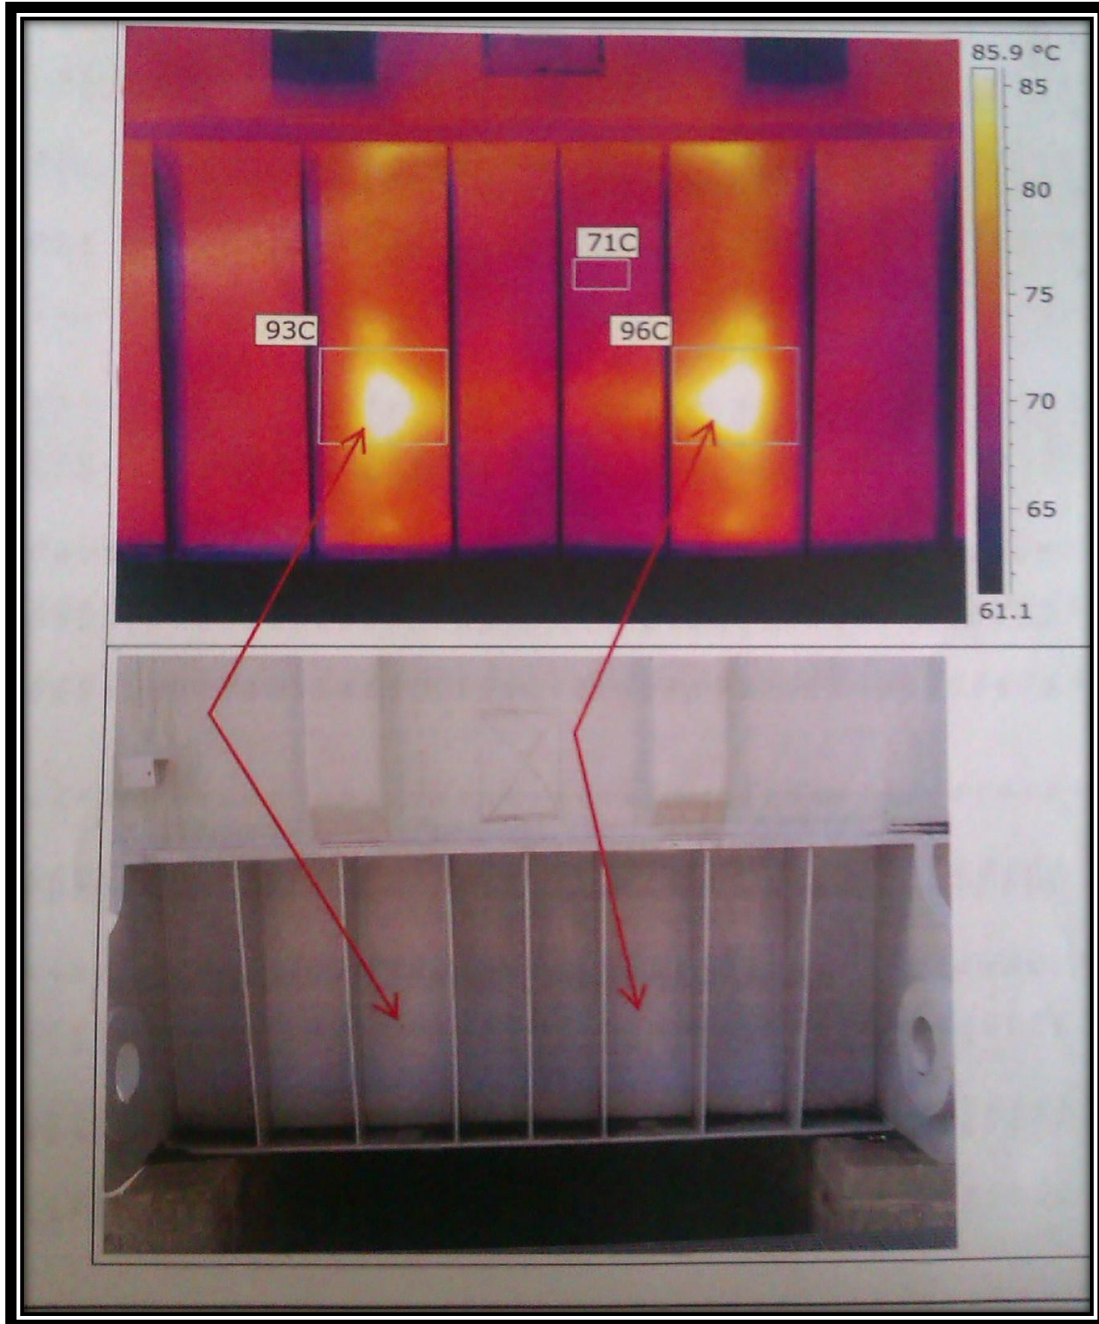
Figure 8
Thermal Picture Comparison of the Unit 2 Transformer

Recently, thermal images were taken of the transformer we are assessing which indicated that there were areas of extreme heat compared to the rest of the transformer, in Figure 8. Reasons why there was a high water content in the transformer could be from degradation in the solid insulation material

between the coils of the transformer. Natural wear on the solid insulation could pose health problem with the transformer because this drops the insulating material's strength. Drops in the solid insulating material strength can cause arching between the coils inside of the transformer and cause local hot spots in certain areas of the transformer. Common among many of the transformer failures is a short turn. The shorted turn develops as a result of breakdown of the solid insulation which causes winding temperature to shoot up. The transformer shows signs of a short turn which would suggest that it's at the end of its life.
