Northern Arizona University

APS Transformer Final Report

Cholla Unit 2 Generation Step Up XFMR

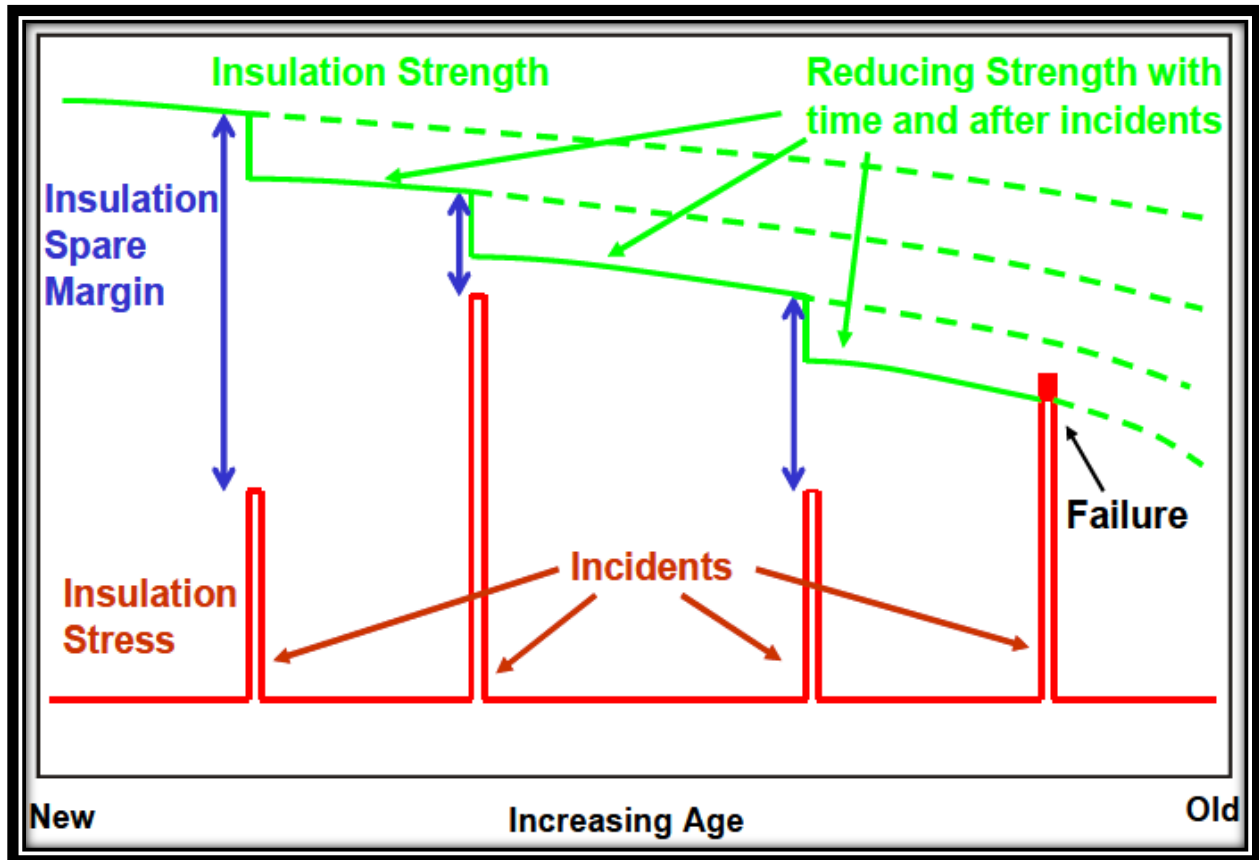
Figure 9
A Conceptual Failure Model

Further tests need to be done to get condition assessment for the transformer. Figure 9 describes the characteristics of a transformer when the insulation age drops after certain high load stresses. It can be seen that past failures and stress affect the state of the transformer. When additional tests are completed during and after the outage we can make our condition assessment.
